CRS No. A-00002

Name: Dwelling, 249 Bowers Beach Road

CULTURAL RESOURCE SURVEY
PROPERTY IDENTIFICATION FORM

1. HISTORIC NAME/FUNCTION: Dwelling, 249 Bowers Beach Road
2. ADDRESS/LOCATION: 249 Bowers Beach Road
3. TOWN/NEAREST TOWN: Little Heaven vicinity? ☒
4. MAIN TYPE OF RESOURCE: building ☒ structure ☐ site ☐ object ☐
 landscape ☐ district ☐
5. MAIN FUNCTION OF PROPERTY: Residential
6. PROJECT TITLE/ REASON FOR SURVEY (if applicable):
SR1, Little Heaven Grade Separated Intersection Improvements

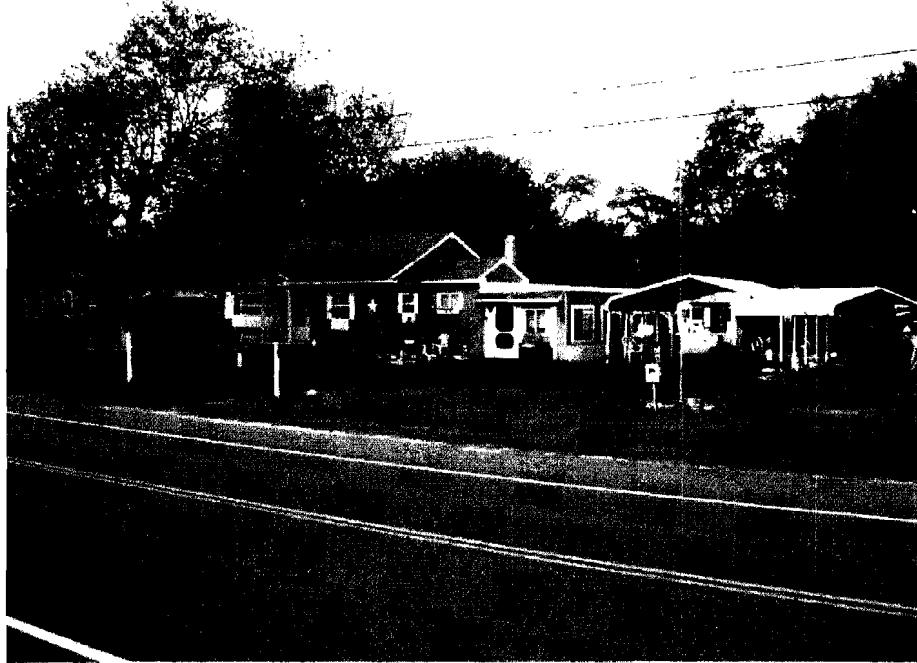
A-00002. Photograph 1: Overview of 249 Bowers Beach Road, looking northwest. This dwelling was constructed by the Roberts family ca. 1955.

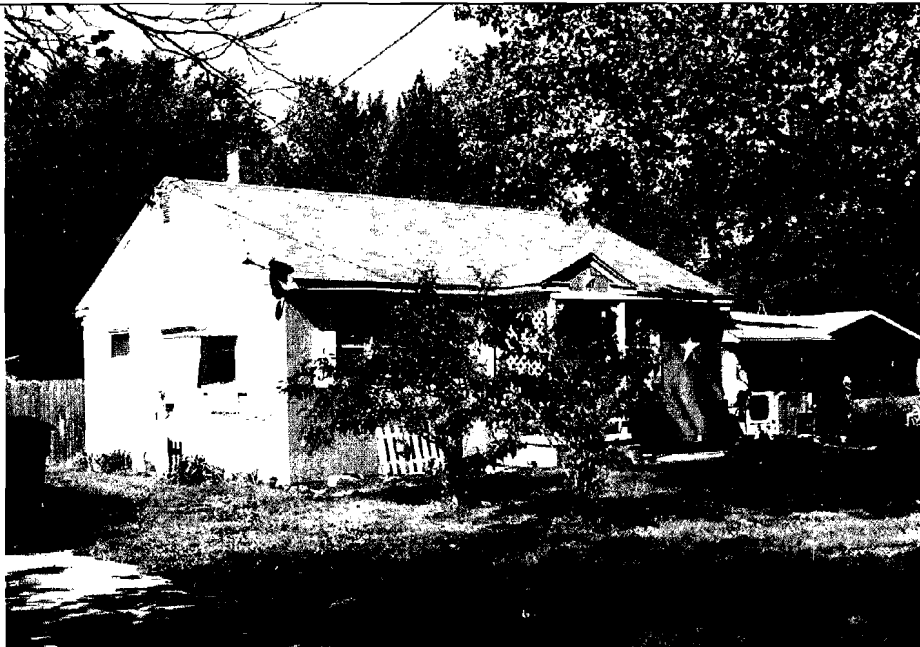
A-00002. Photograph 2: Dwelling, west and south elevations, looking north. This side-gable dwelling is clad in stucco and asbestos shingles and is primarily lit by one-over-one light, double-hung sash, vinyl replacement windows.

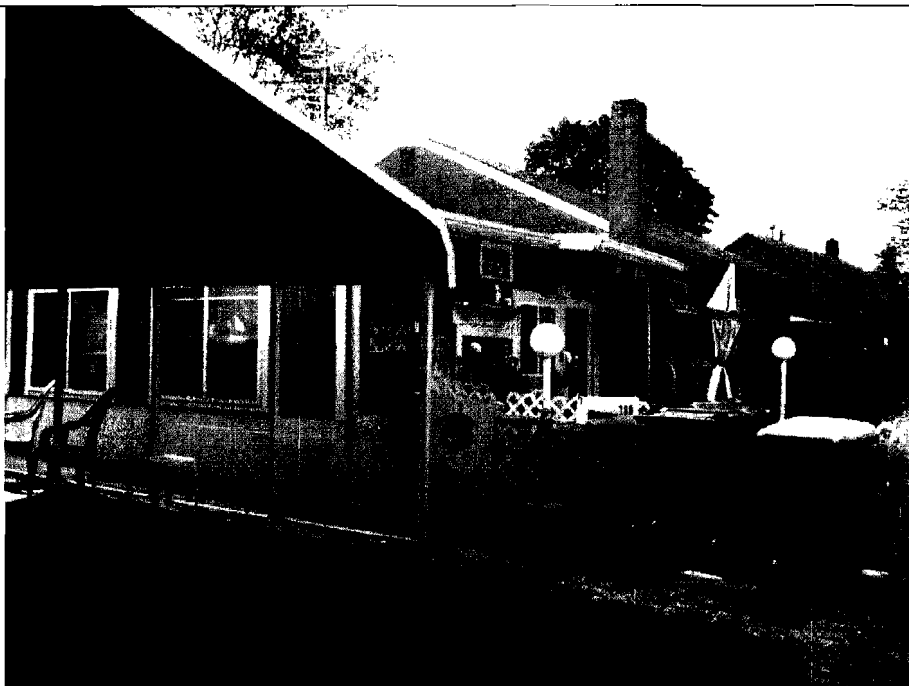
A-00002. Photograph 3: Dwelling, east and north elevations, looking southwest towards the addition. The carport in the left half of the photograph is modern.

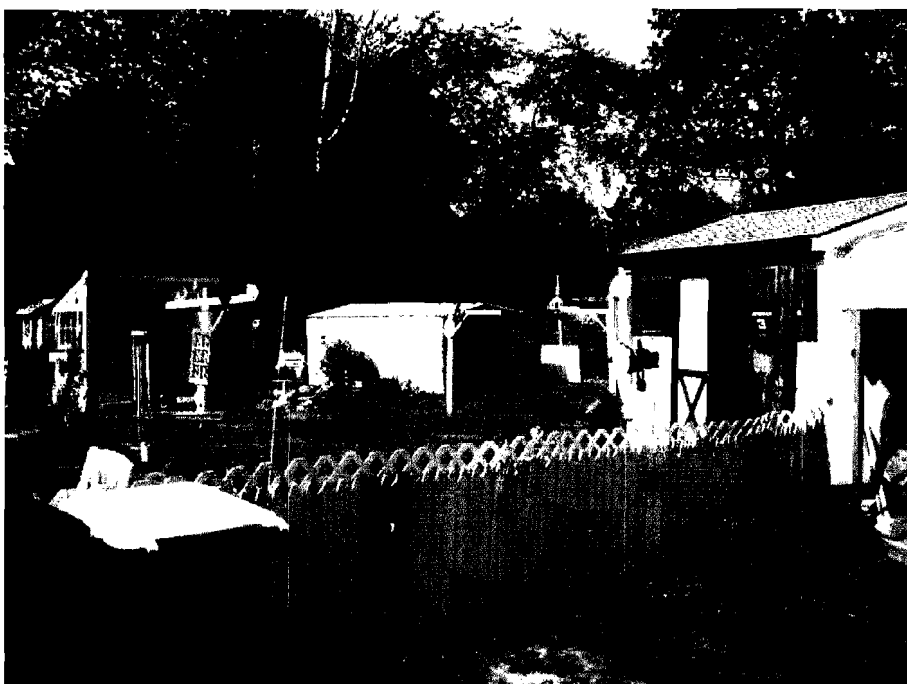
A-00002. Photograph 4: Overview of rear yard, looking northwest. The tool shed located on the left side of the photograph is the lone outbuilding on the property constructed before 1961.
